MC BUILDING
SOLUTIONS LTD

CASE STUDY

PLAYGROUND REFURBISHMENT
LUTON, BEDFORDSHIRE

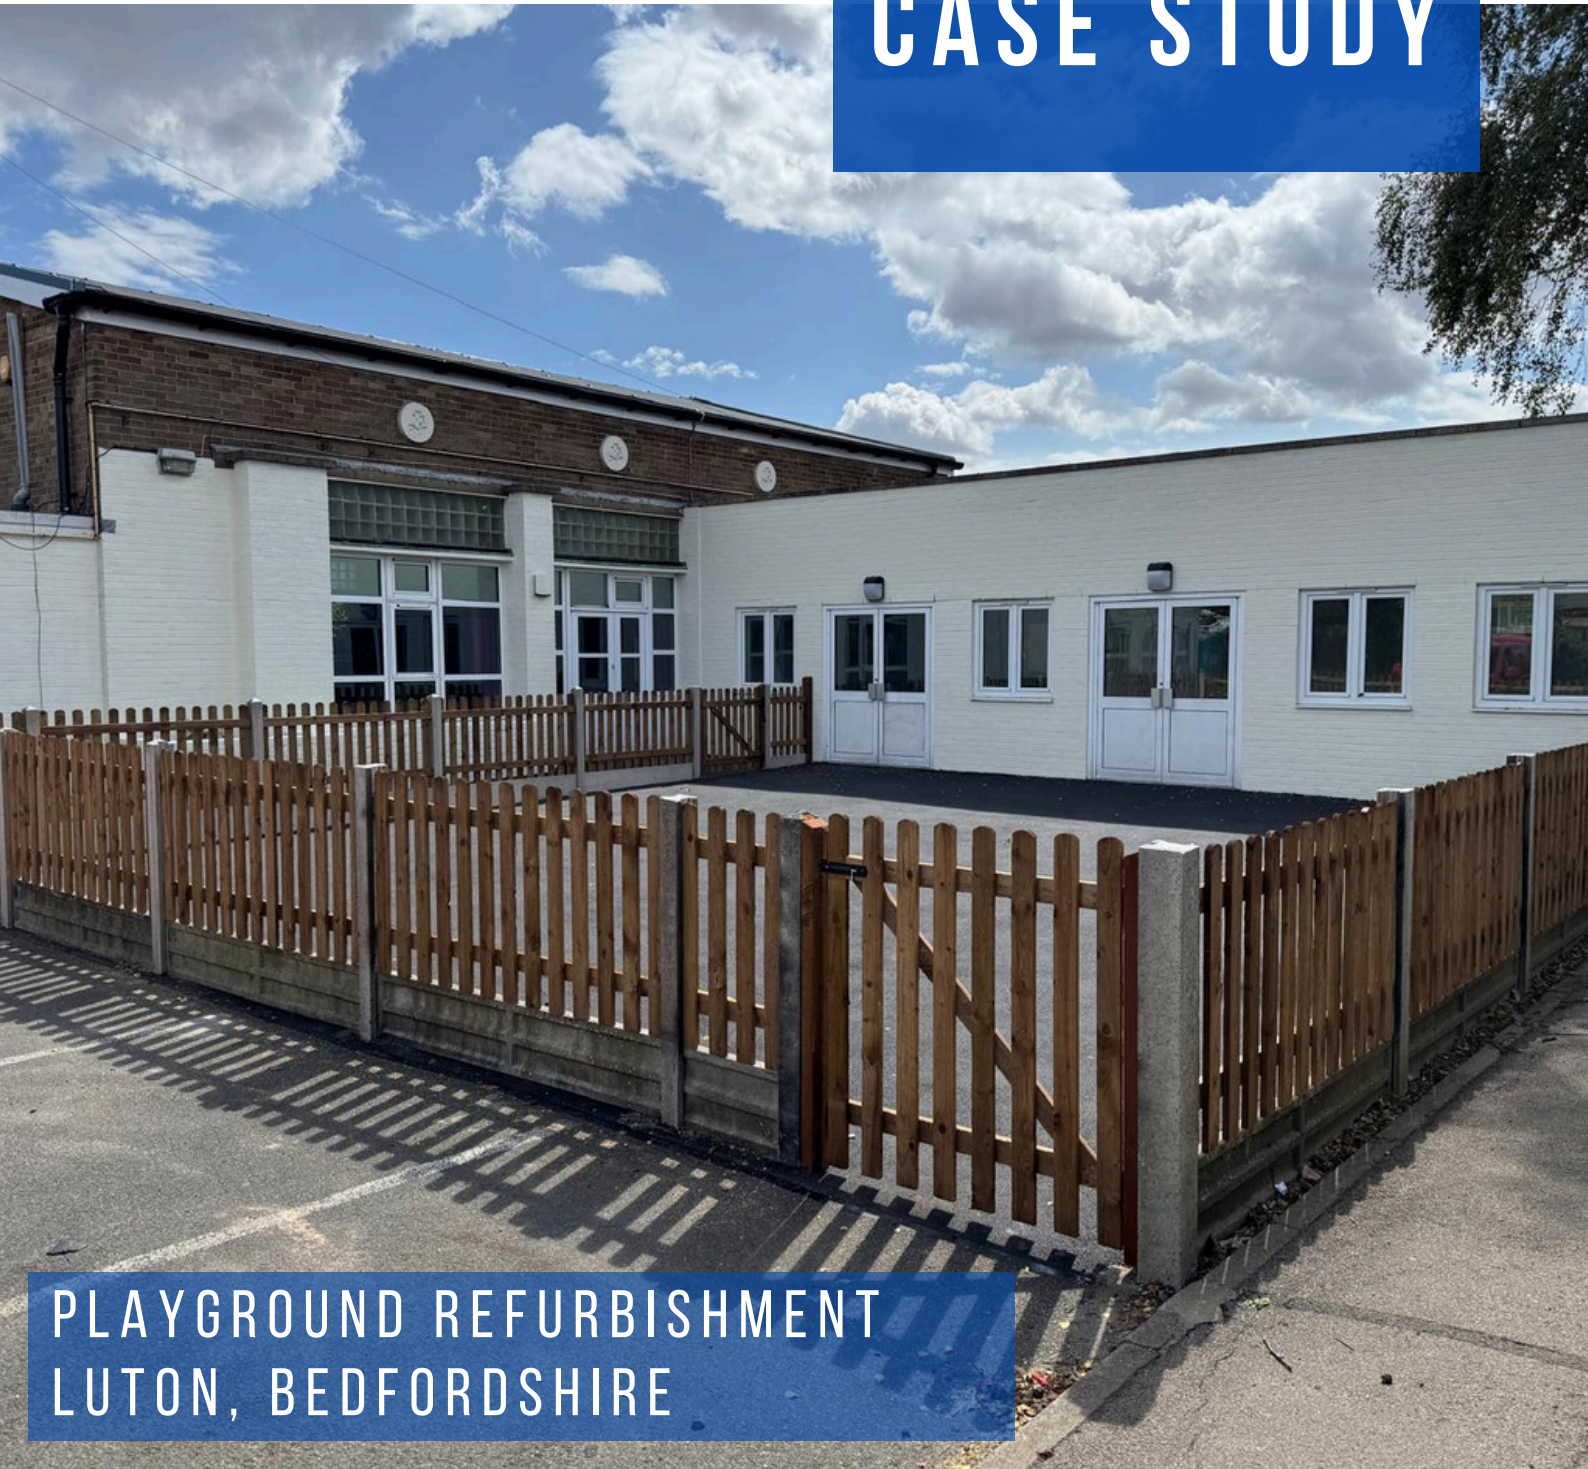
We were asked to complete a playground revamp project for Ramridge Primary School, Luton, during the summer holidays. This project was split into two sections; the playground and the rear pathway.

- We cut down the concrete posts and dug out to the existing sub base (not exceeding 100mm)
- Installed new concrete posts to form walkway with 3no gates
- Installed 2m x 1.2m high picket fence panels and 3no gates
- Applied a tack coat and laid new 30mm AC6 DBM sur 50pen
- Decorated the walls to the main building

- Grinded off area and applied a tack coat
- Laid new 30mm AC6 DBM and dug out the grassed area
- Installed edging, laid MOT type 1 and consolidate
- Handlaid 60mm AC 14 DBM Binder 125pen
